Technical Bulletin: The White Line Syndrome

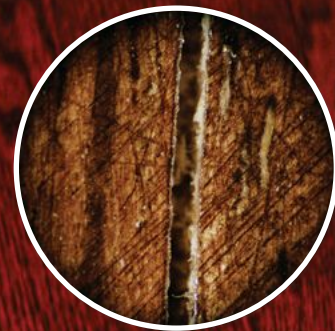
Fig 2: InfinityII under Infinity II w/ProLink

During our testing of waterborne coatings we found that while they all showed white lines to some extent, Infinity II was found to show the least amount of white lines. Unlike other waterborne coatings, **Infinity II fractures as the floor expands and contracts.**

Sometimes there are residual stress fractures on the edge of the board where the coat does break and this can appear as a semi-transparent line from a standing position.

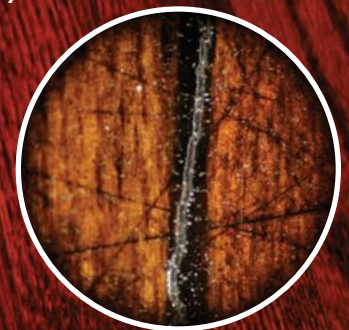
Fig 4: Quality Seal & GlitsaMax

Waterborne coatings have the potential to produce white lines over dark-stained floors as well, but how noticeable the lines are varies widely. In testing isocyanate-crosslinked waterborne finishes (*HP, GlitsaMax and competing brands*), we found that white lines appear at varying severities.

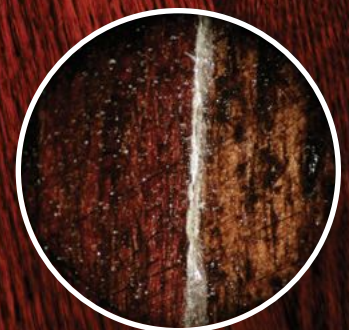
Fig 6: Shellac under Waterborne

Shellacs - Tests using a shellac under a waterborne topcoat showed white lines (see fig. 6).
